## Laboratory Test Report

Document No.: 284-23

Equipment Under Test: MRL003RiEU61-07-1.8

Client: EH4 GmbH  
Rimsinger Weg 2  
D-79111 Freiburg

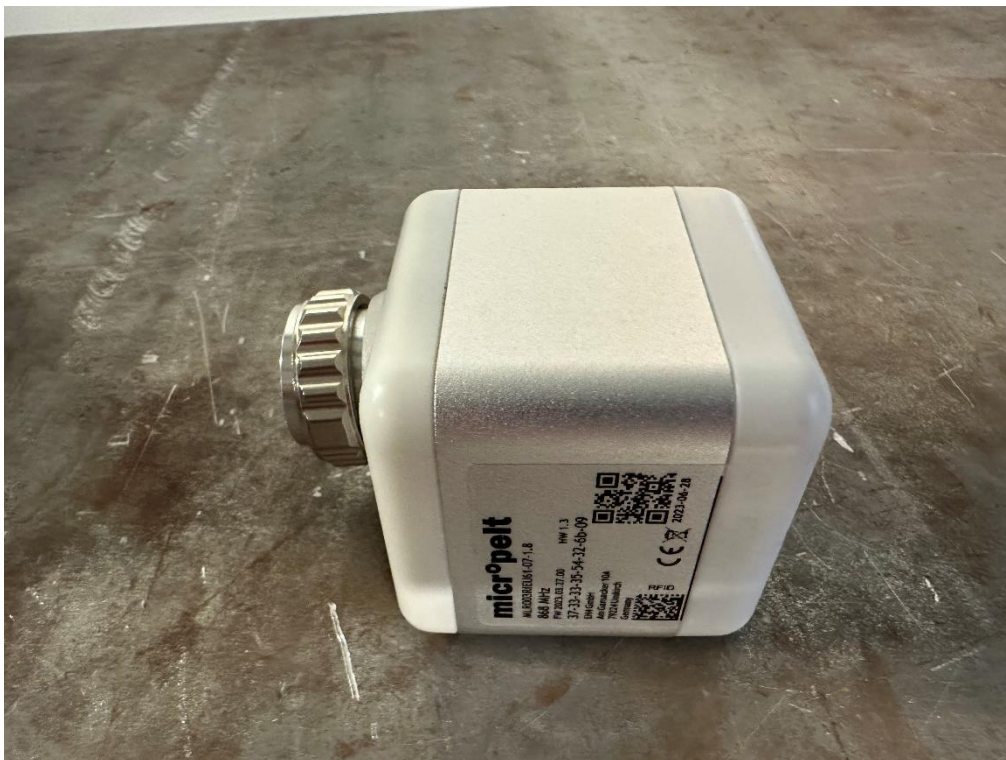
Figure 1: Equipment under test No. 01.

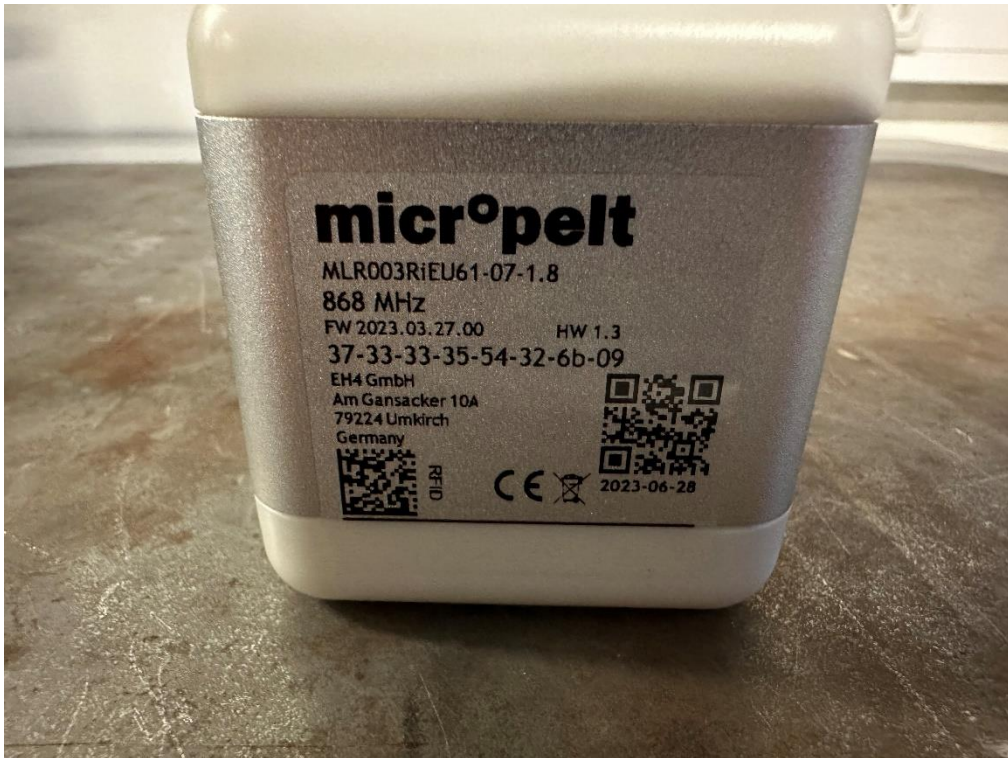
Figure 2: Label of equipment under test No. 01.

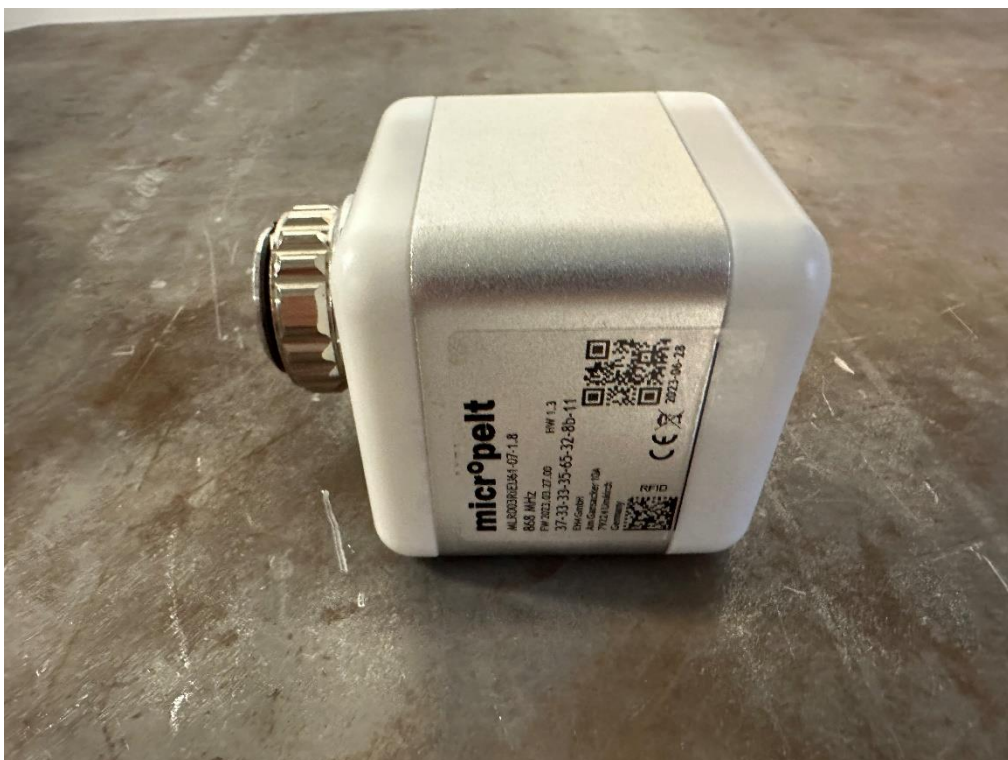
Figure 3: Equipment under test No. 02.

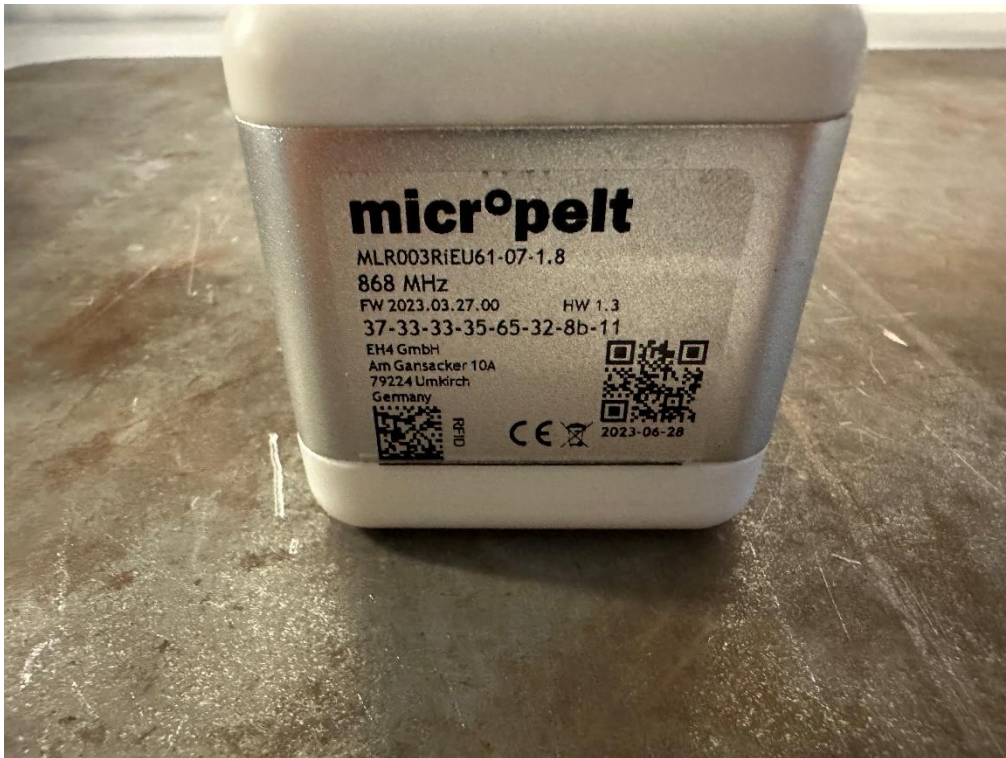
Figure 4: Label of equipment under test No. 02.

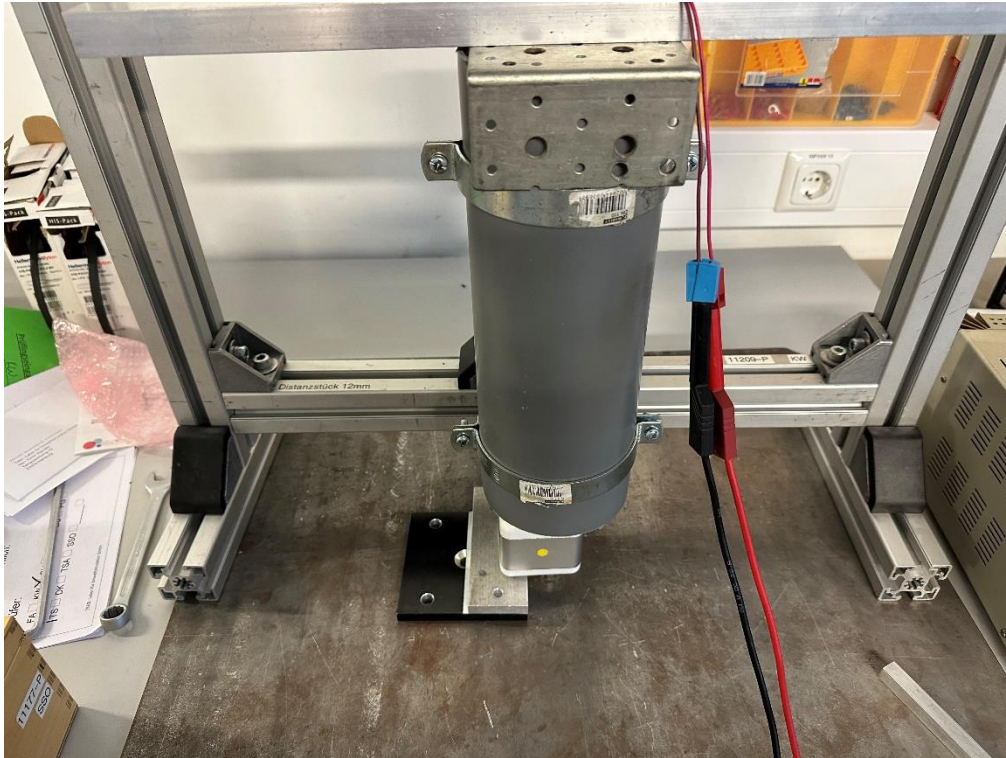
Figure 5: Exemplary picture of the test set-up.

Parameter	Value	Comment
Weight [kg]	5.0	./.
Height of fall [mm]	200	./.
Energy [J]	10	./.
Numbers of positions	min. 5	./.
Numbers of positions for EUT 01	5	Impact positions were marked in agreement with the client.
Numbers of positions for EUT 02	5	Impact positions were marked in agreement with the client.

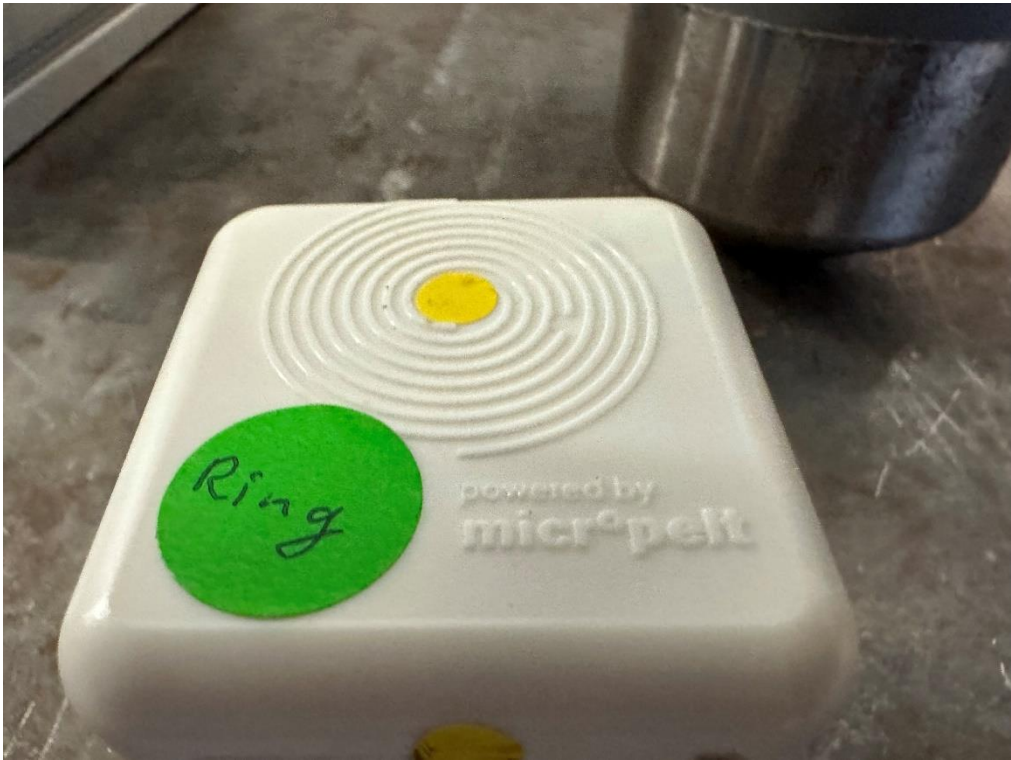
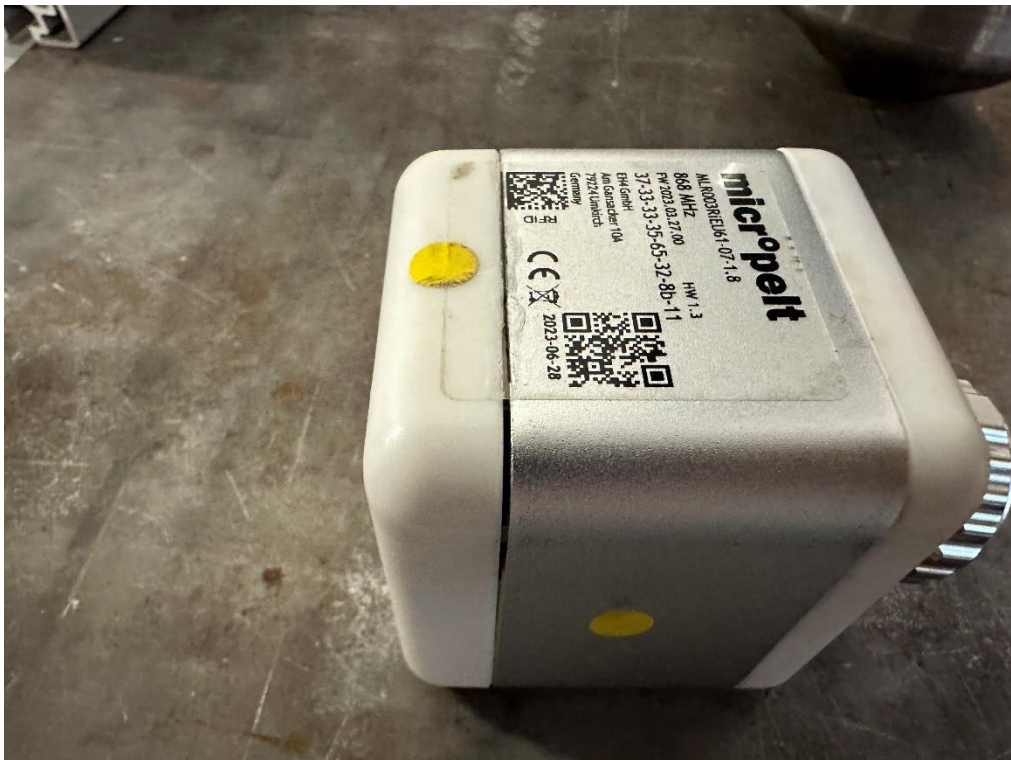
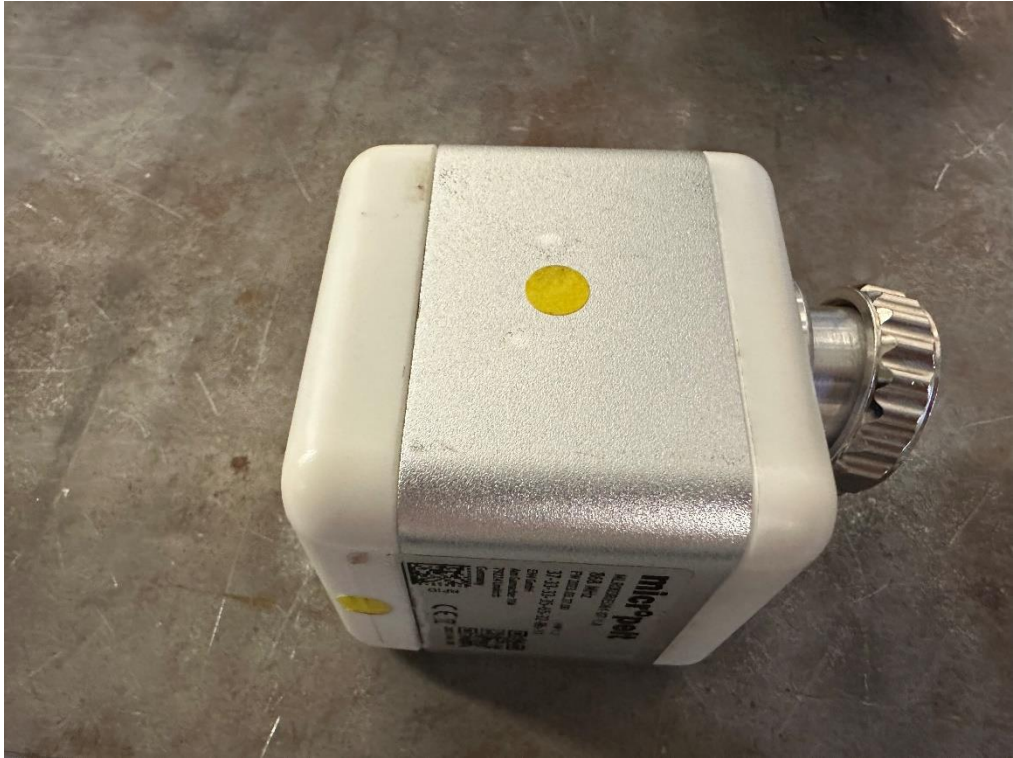
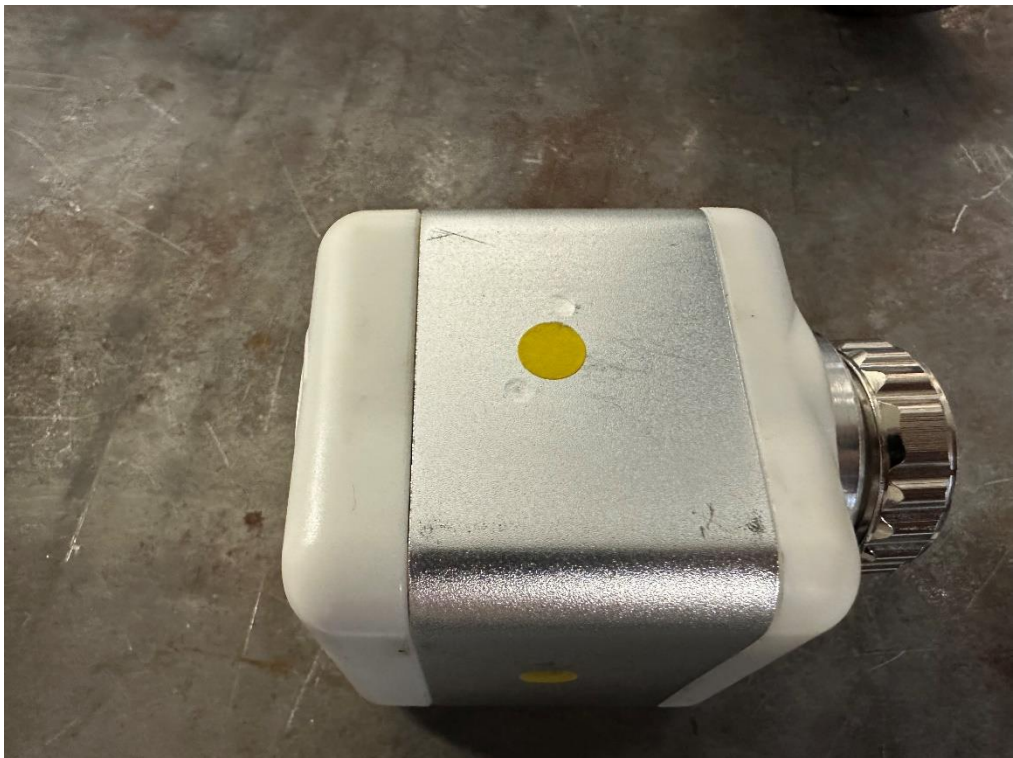
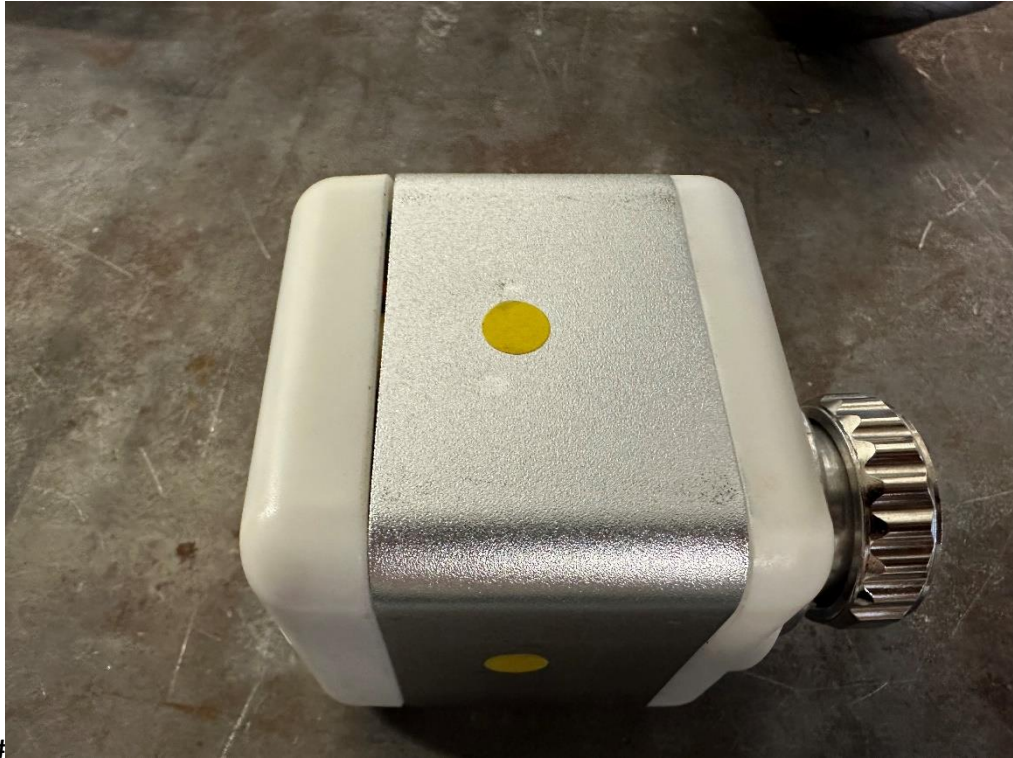
4.6.1 Results EUT No. 01

During the naked eye visual inspection after the test, damages were detected. Please refer to the respective figures.

The 1mm probe did not enter the EUT.

<b>EUT No.</b>	<b>Result</b>	<b>Comment</b>
01	Passed	The gap increased
02	Passed	Cracks were detected

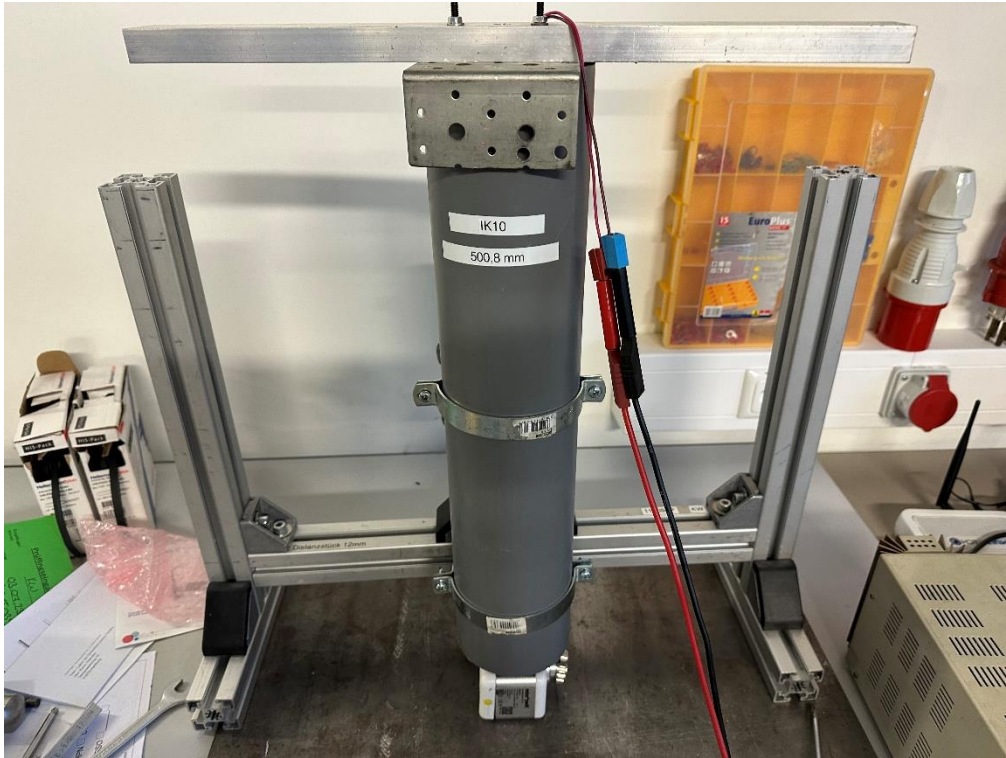
Figure 16: Exemplary picture of the test set-up.

Parameter	Value	Comment
Weight [kg]	5.0	./.
Height of fall [mm]	400	./.
Energy [J]	20	./.
Numbers of positions	min. 5	./.
Numbers of positions for EUT 01	5	Impact positions were marked in agreement with the client.
Numbers of positions for EUT 02	5	Impact positions were marked in agreement with the client.

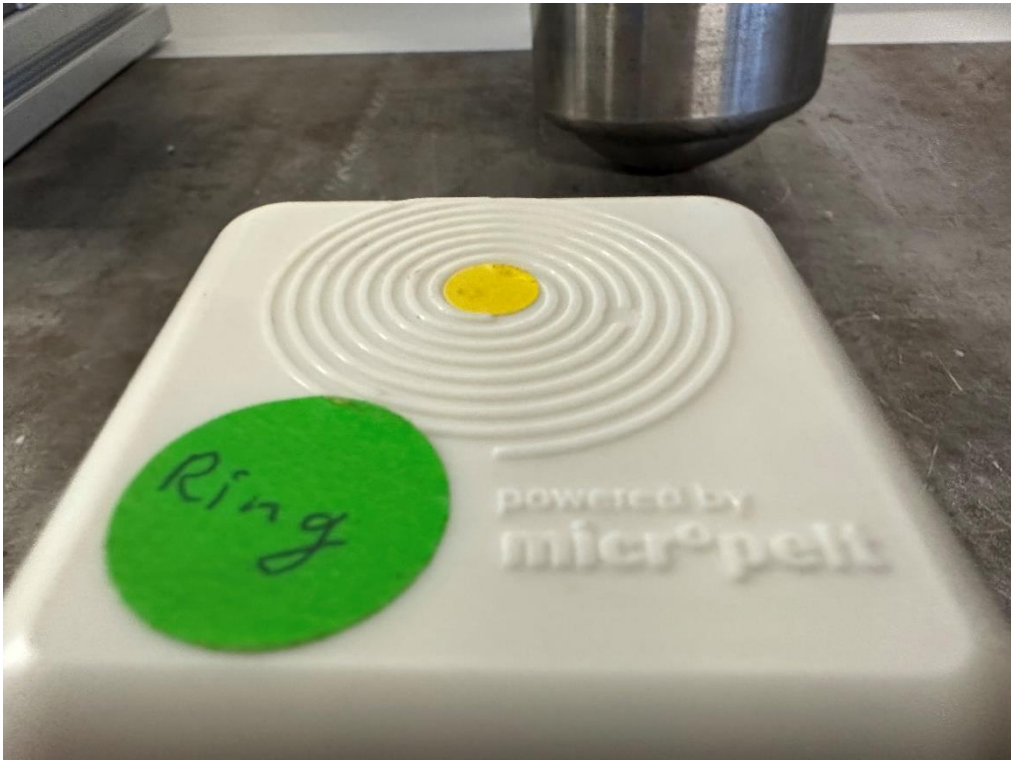
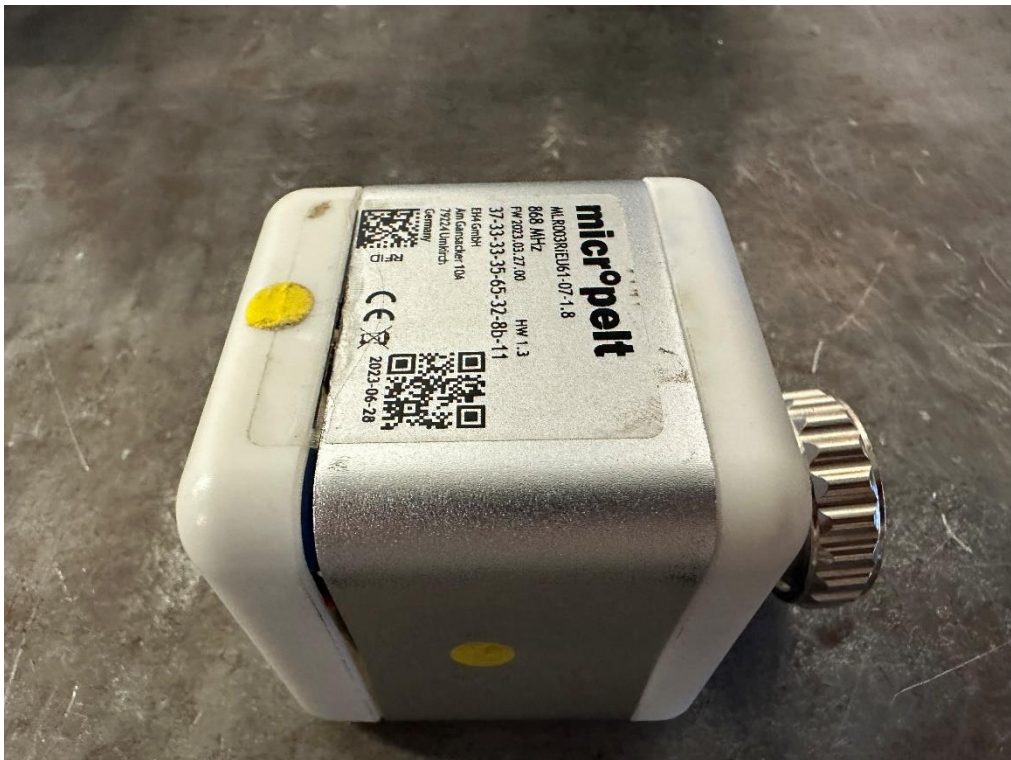
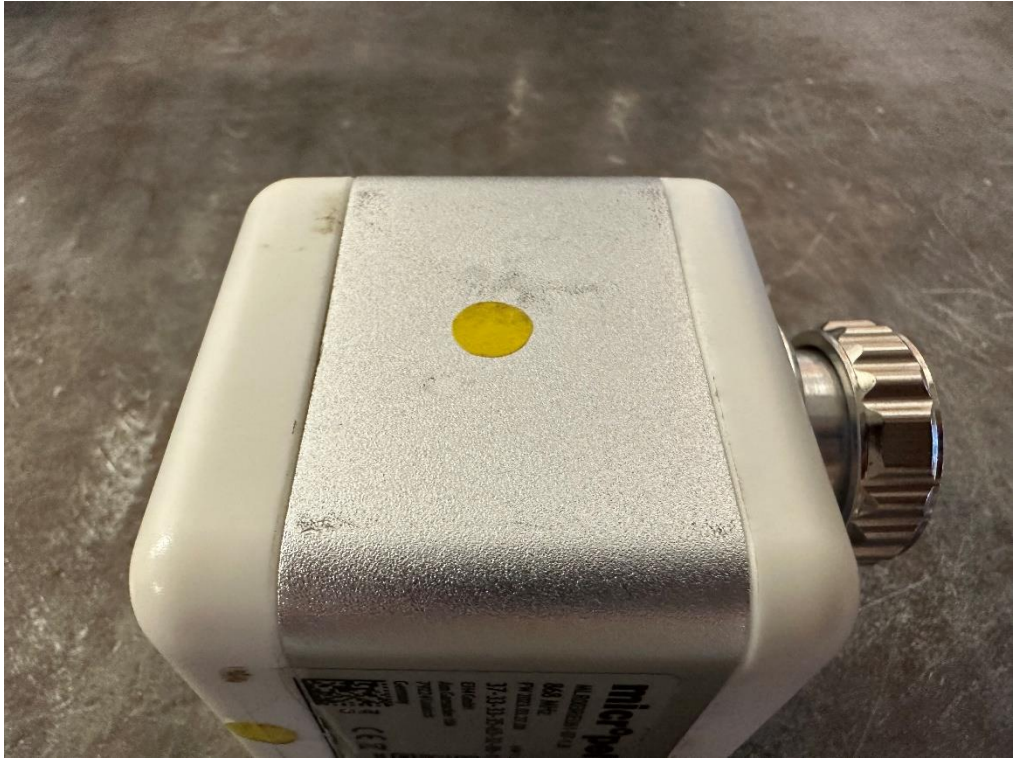
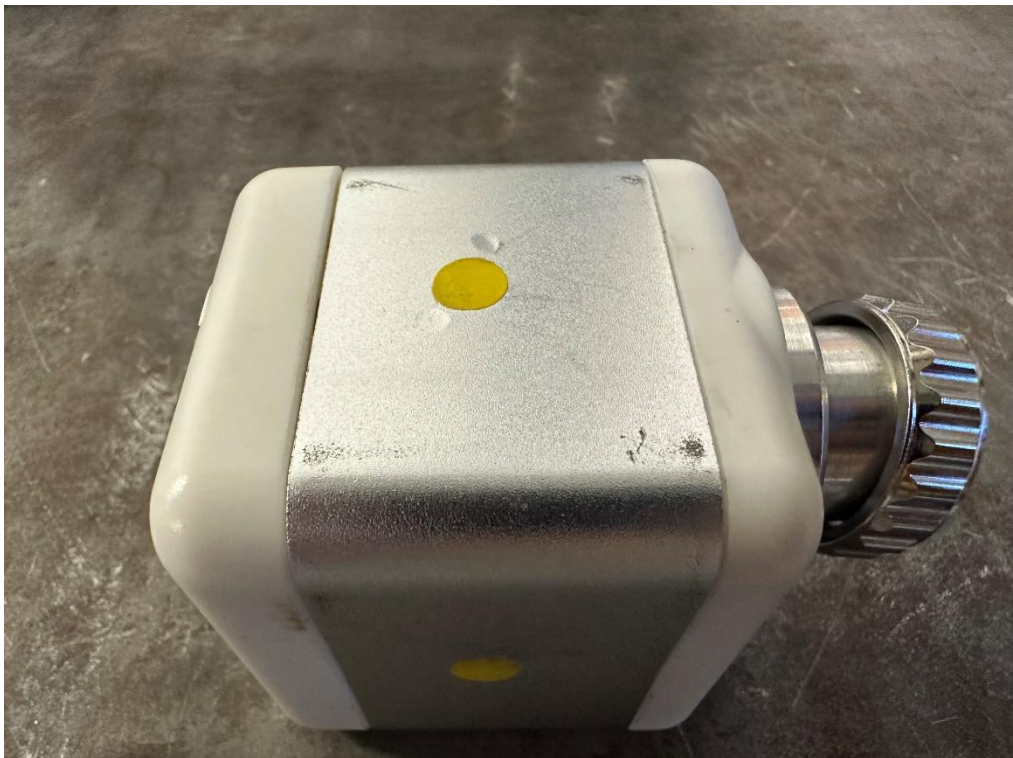
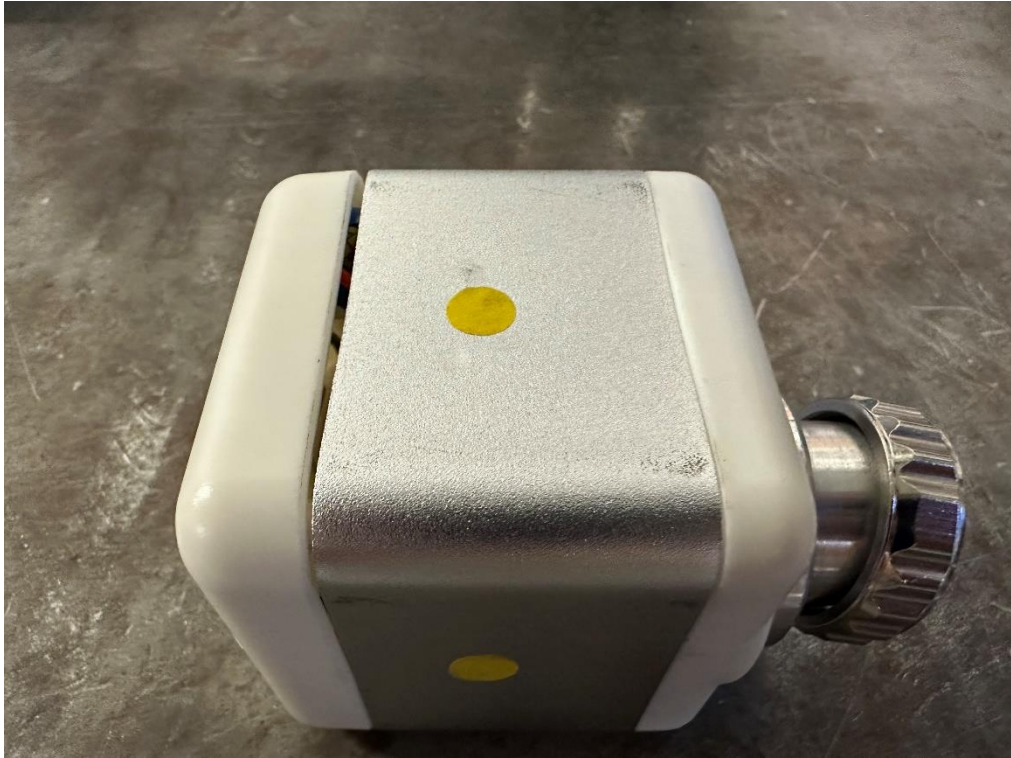
5.6.1 Results EUT No. 01

During the naked eye visual inspection after the test, damages were detected. Please refer to the respective figures.

The 1mm probe did enter the EUT.

<b>EUT No.</b>	<b>Result</b>	<b>Comment</b>
01	Failed	The gap increased
02	Failed	Cracks were detected, Deformation was detected.
